Edington Parish Council Playground

Behind , 47 Westbury Road, Edington, Westbury, BA13 4PG

2026 Equipment Inspection Report

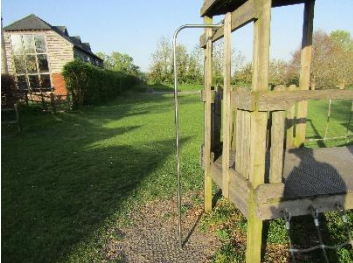
<p>Fireman's Pole</p> <p>Fair > Poor Condition - Grip requirements met (16mm – 45mm) of BS EN 1176 Part 1. No damage to metal surfaces. with pole firmly fixed and secure into the play surface</p>
<p>4</p>

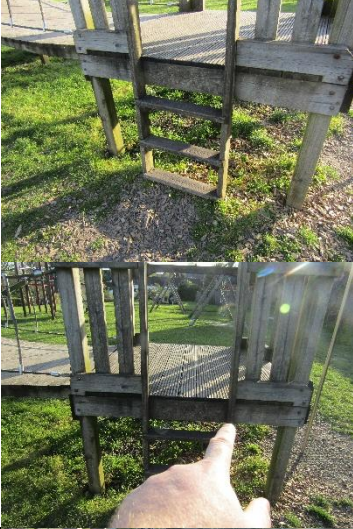
<p>Timber Steps / Ladder</p> <p>Fair Condition - Timber worn with age related wear evident but sound with no roughness to frame or rungs, splintering or cracking and safe to use at time of inspection. Some minor movement in left side timber upright support as indicated - Monitor</p>
<p>5</p>

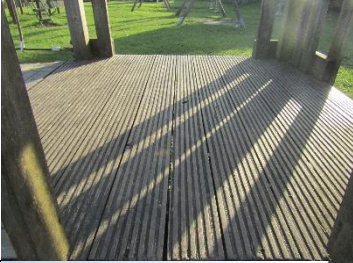
<p>Platform (2)</p> <p>Generally in Fair Condition throughout with all timber platform, frame sections & fixings checked secure with no significant damage evident at time of inspection.</p>
<p>6</p>

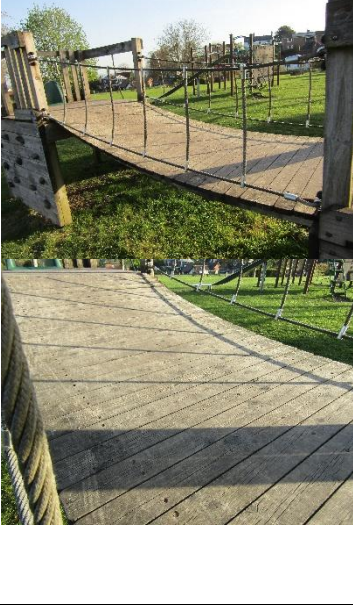
<p>Bridge</p> <p>Fair Condition - Bridge frame and supporting Timbers all sound with age related wear. No significant Timber damage evident. Fixings checked tight and secure with no significant wear or wire splintering evident in ropes. Evidence of being highly slippery in damp conditions.</p> <p>Recommend fitting with non-slip safety surface during next maintenance cycle.</p> <p><i>Quotations for carrying out equipment Repairs and Replacement of parts are available on request.</i></p> <p><i>Repairs / Recommended Maintenance :- To supply & Fit new heavy duty High Visibility Resin Anti Slip strips with silicone fixing and frame screws to each bridge tread board @ £295.00 (Includes 5 year guarantee)</i></p>

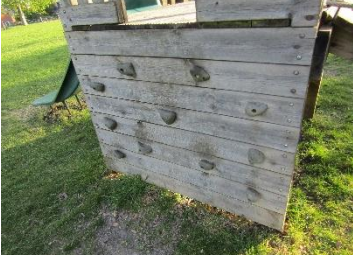
<p>Climbing Panel</p> <p>Fair Condition - with Hand and Foot holds checked and tightened where necessary. Timber surfaces checked smooth with no splinter risks at time of inspection. High use areas such as Traversing Walls require regular checking for the security of all fixings and potential splintering risks</p>

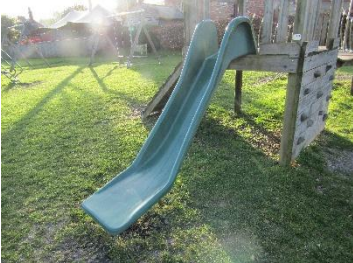
<p>Slide</p> <p>Fair Condition – Structure and frame securely attached to entrance platform and ground surface with no free movement, exposed fixings or fatigue present in Slide securing points & edges. Slide Chute surfaces are smooth with no cracking, fractures or splintering evident at time of inspection.</p>
<p>9</p> <p>

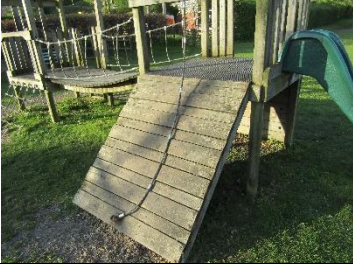
<p>Ramp & Pull Rope</p> <p>Fair Condition - With timber ramp sections and fixings secure. Wire cored rope all sound with ferules tight & Secure, no frayed or splintering wire evident. High use areas such as climbing ramps require regular checking for the security of all fixings.</p>
<p>10</p> <p>

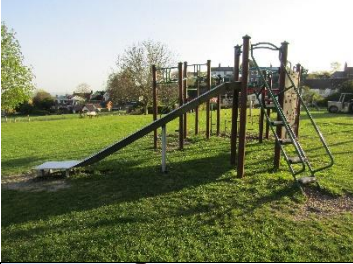
<p>MPU (2)</p> <p>Fair Condition - The frame structure generally complies with BS EN 1176 standards. Subject to any recommended repairs / maintenance recommended being carried out. The equipment is considered sound & safe to use at time of inspection and although ageing still sound and safe to use at the time of inspection.</p>

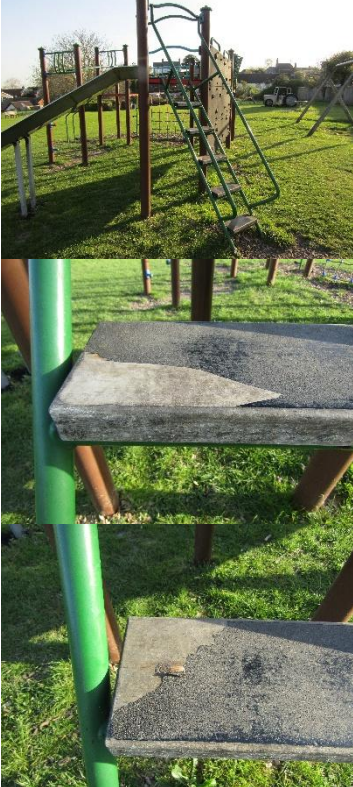
<p>Ladder</p> <p>Fair Condition with no movement at base level. Ladder rungs secure with all fixings present and tight and secure</p> <p>2 steps found with detaching anti slip surfacing peeling away – Maintenance recommended to fit rigid anti slip strips</p> <p><i>Repairs / Recommended Maintenance :- To supply & Fit new 60cm heavy duty High Visibility Resin Anti Slip strips with silicone fixing and frame screws @ £145v(Includes 5 year guarantee)</i></p>
<p>12</p> <p>

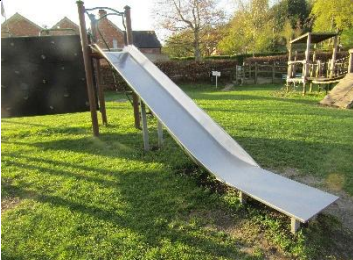
<p>Steel Slide</p> <p>Frame in Fair Condition with sound welds, undamaged surfaces. Rail structure securely attached to entrance platform and ground surface with no free movement, exposed fixings or fatigue present in frame securing points & edges.</p>

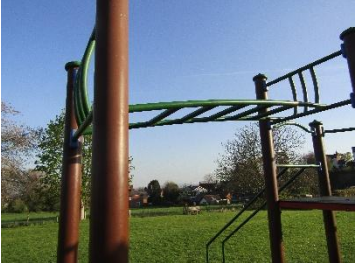
<p>Monkey Bars</p> <p>Fair Condition. All hand bars and frame fixings checked tight and secure with no looseness or twisting in the frame at time of inspection.</p>
<p>14</p>

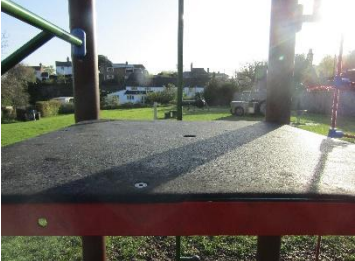
<p>Platform</p> <p>Generally in Fair Condition throughout with all platform, frame sections & fixings checked secure with no significant damage evident at time of inspection.</p>
<p>15</p>

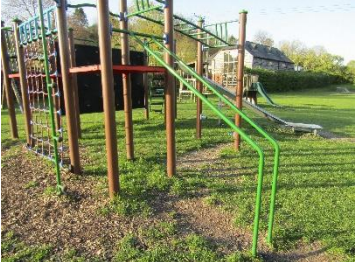
<p>Parallel Poles</p> <p>Fair Condition - No damage to metal surfaces. with poles firmly fixed and secure into the play surface</p>
<p>16</p>

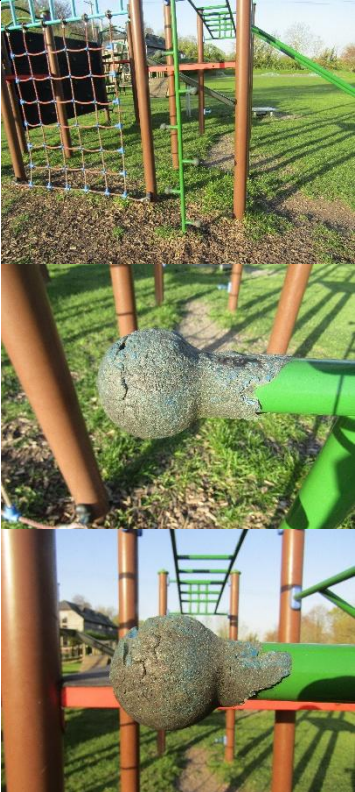
<p>Peg Ladder</p> <p>Fair > Poor Condition – Pegs in Fair Condition with sound welds, undamaged paint surfaces.</p> <p>Rubber grips in Poor Condition due to perishing as highlighted. Recommend replacement to reduce risk of injuries</p> <p><i>This repair / maintenance issue is considered to be a more cost-effective proposition if monitored and carried out by the original equipment suppliers or installers and for this reason DTGS has not provided a repair quotation</i></p>

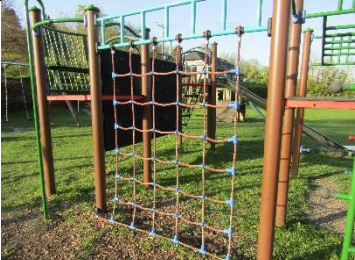
<p>Scramble Net</p> <p>Fair Condition – Net is aged but in a safe and sound condition at time of inspection with secure fixings and frame attachments.</p>

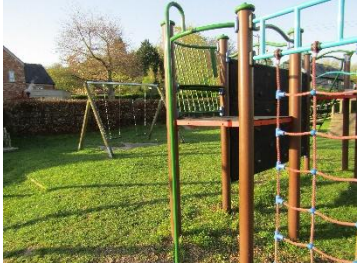
<p>Fireman's Pole</p> <p>Fair Condition grip requirements met (16mm – 45mm) of BS EN 1176 Part 1, with all fixings tight and secure. No damage to metal surfaces. with pole firmly fixed and secure into the play surface</p>
<p>19</p>

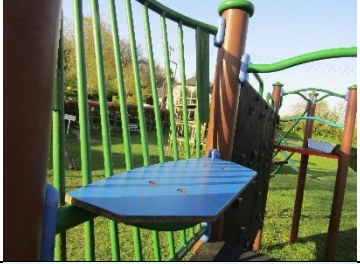
<p>Raised Timber Seat</p> <p>Generally in Fair Condition with all timber seating, ground supports, frame sections , table top and fixings checked secure at time of inspection.</p>
<p>20</p>

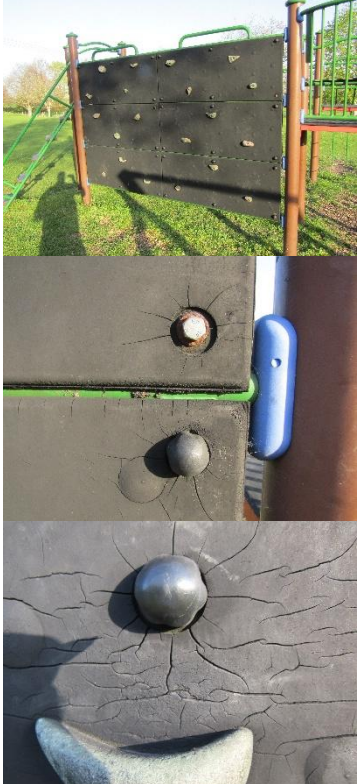
<p>Traversing Panel</p> <p>Fair Condition with Hand and Foot holds checked and tightened where necessary / or possible . High use areas such as Traversing Walls require regular checking for the security of all fixings.</p> <p>1x missing fixing cap presenting exposed fixings and sharp edges – as these are in areas easily accessible to users recommend re fitting caps to reduce risk of potential abrasion injuries</p> <p><i>This repair / maintenance issue is considered to be a more cost-effective proposition if monitored and carried out by the site maintenance team and for this reason DTGS has not provided a repair quotation</i></p> <p>Rubberised backboard is beginning to crack as highlighted – Monitor</p>

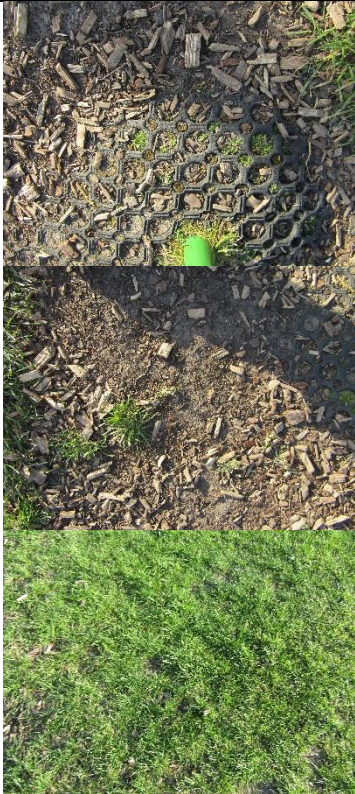
Fair Condition with all matting secured to play surface with apposite ground fixings, seated edges into the surface with no areas of damage or trip hazards identified at time of inspection

The level of loose filling has fallen significantly below the minimum of 200mm recommended by BS EN 1176 Part 1. Recommend topping up loose fill surfacing to recommended minimum levels.

Fair Condition - The surface is generally even with no significant areas of damage , wear or tripping hazards identified. Some higher use areas have eroded resulting in compacted open areas of soil which is slippery in damp conditions. Recommend reinstatement of surface during next maintenance cycle

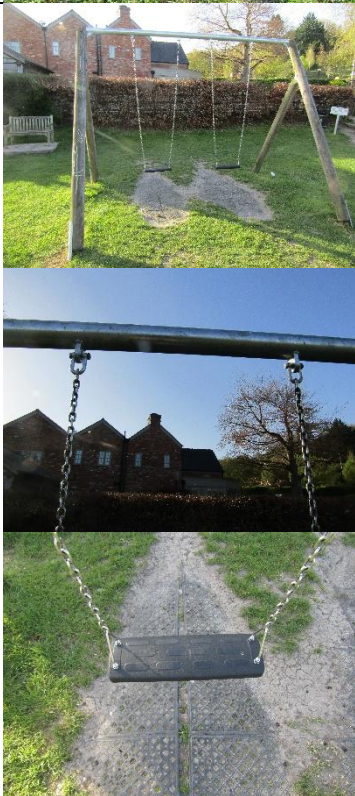
Fair Condition - Timber frame is generally weathered and worn with age related wear.

Both swings move smoothly and noiselessly
Chains and safety shackles checked and secure with minimal wear evident.
Pivot pins, bushes secure and free from excessive movement. All chain connections checked intact and secure with minimal wear evident.

Good Condition with no damage or cracking to EPDM rubber seat or Aluminium insert reinforcement. Seats set at compliant heights. Chain connections, fixings checked tight & Secure.

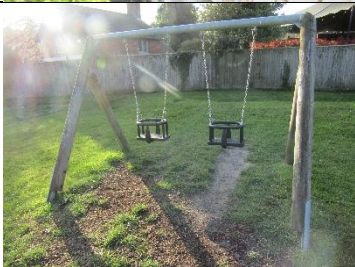
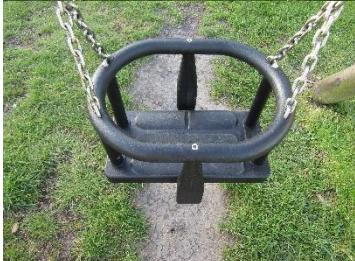
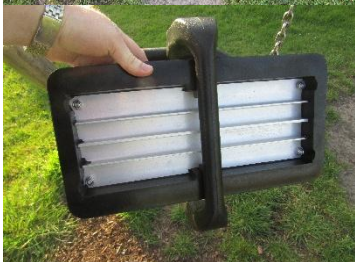
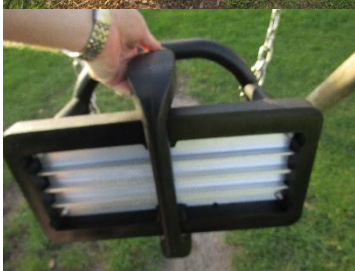
Fair Condition - Timber frame is generally weathered and worn with age related wear.

Both swings move smoothly and noiselessly

Chains and safety shackles checked and secure with minimal wear evident. Pivot pins, bushes secure and free from excessive movement. All chain connections checked intact and secure with minimal wear evident.

Good Condition with no damage or cracking to EPDM rubber seat or Aluminium insert reinforcement. Seats set at compliant heights. Chain connections, fixings checked tight & Secure.

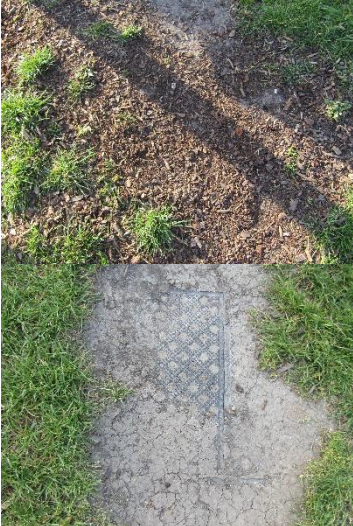
<p>Safe Surface</p> <p>Loose Fill: The level of loose filling has fallen significantly below the minimum of 200mm recommended by BS EN 1176 Part 1. Recommend topping up loose fill surfacing to recommended minimum levels.</p> <p>Rubber Tiles: Fair > Poor Condition with all matting secured to play surface with apposite ground fixings, seated edges into the surface with no areas of damage or trip hazards identified at time of inspection Protective rubber matting is compacted into the muddy ground surface and no longer impact absorbing.</p>
<p>28</p>

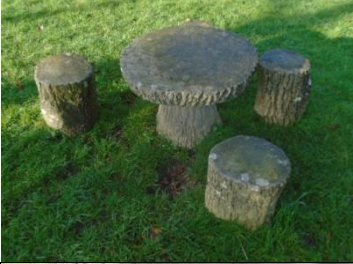
<p>Timber Seating and Table</p> <p>Fair Condition with all timber seating, ground supports, frame sections and fixings checked secure at time of inspection.</p>
<p>29</p>

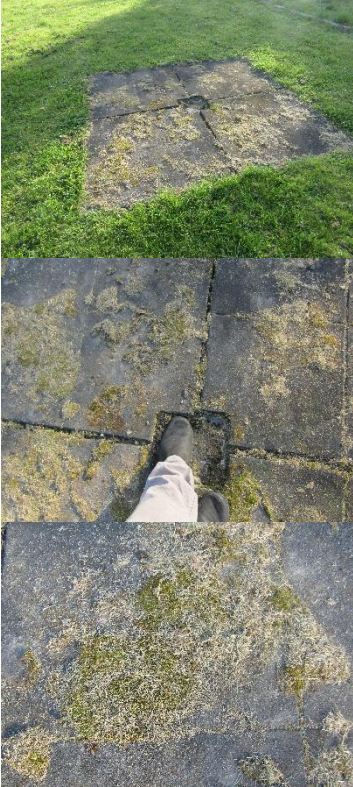
<p>Safe Surface (where previous equipment was installed)</p> <p>Rubber Tiles Fair > Poor Condition with all matting secured to play surface with apposite ground fixings, seated edges into the surface. There are holes where previous equipment has been removed presenting trip hazards as highlighted. Excessive weed & Moss growth in surrounding areas. Recommend this is treated to reinstate safe surface and avoid further damage to surface edging . Weed growth in safety surfaces also leads to tripping points , particularly in damp conditions. Recommend removal of weeds and treatment of surface with playground safe weed control.</p> <p>Maintenance recommended to repair / reinstate safety surface during next maintenance cycle</p> <p><i>This repair / maintenance issue is considered to be a more cost-effective proposition if monitored and carried out by the site maintenance team and for this reason DTGS has not provided a repair quotation</i></p>

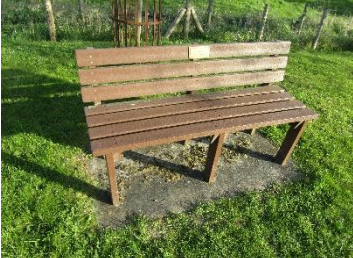
<p>Composite Bench</p> <p>Good > Fair Condition with all composite Plastic seating, table top, frame sections and fixings checked secure at time of inspection. Support sections firmly seated / embedded / attached to playground surface.</p>

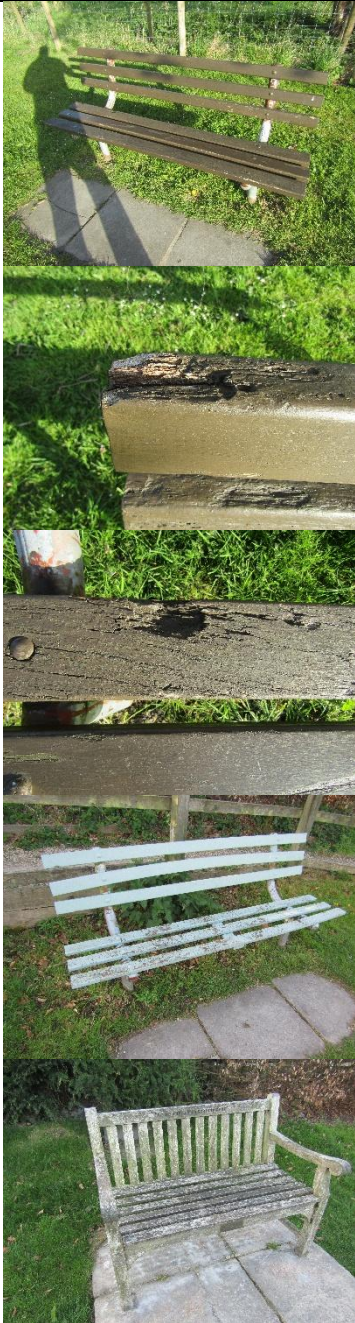
2 Fair Condition with all timber seating, ground supports, frame sections and fixings checked secure at time of inspection.

1 Fair > Poor Condition with all timber seating, frame sections and fixings checked secure at time of inspection. Some timber decay / damage to seating timbers presenting splinter injury risk . Maintenance required the repair / replace affected timber and fixings to reduce injury risk

This repair / maintenance issue is considered to be a more cost-effective proposition if monitored and carried out by the site maintenance team and for this reason DTGS has not provided a repair quotation

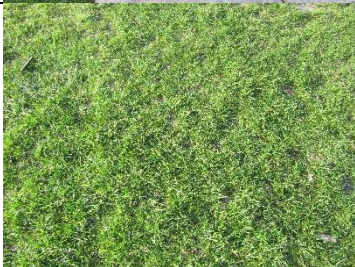
Fair > Poor Condition – The grass surface has eroded significantly in some areas of high use and is very muddy in wet / damp conditions easily leading to trips, slips and falls. The current surface fails the compliance requirements of BS EN 1177. Recommend that the protective surface is reinstated.

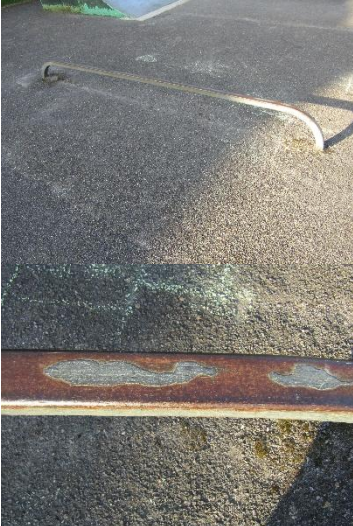
<p>Skate Rail 1</p> <p>Fair Condition: Equipment meets manufacturer’s specifications with age related general wear, all sections and fixings checked secure and sound. Equipment passed safe for its intended use at time of inspection.</p> <p>Some rusting present as highlighted –Monitor</p>
<p>2</p>

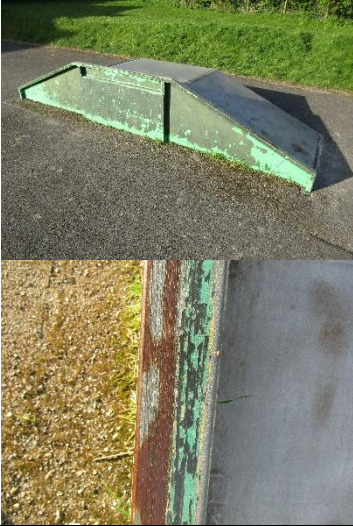
<p>Skate Ramp 2</p> <p>Fair Condition: Equipment meets manufacturer’s specifications with age related general wear, all sections and fixings checked secure and sound. Equipment passed safe for its intended use at time of inspection.</p> <p>Some rusting present as highlighted on side rail sections–monitor</p>
<p>4</p>

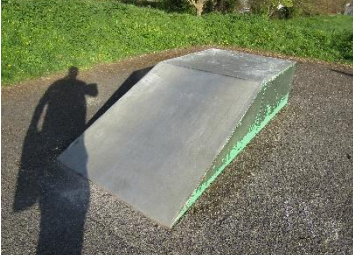
<p>Skate Ramp 3</p> <p>Fair Condition: Equipment meets manufacturer’s specifications with age related general wear, all sections and fixings checked secure and sound. Equipment passed safe for its intended use at time of inspection.</p>

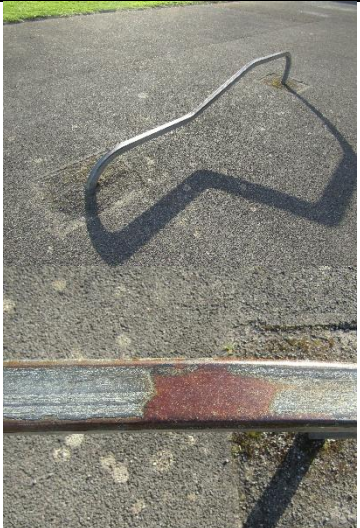
<p>Skate Rail 2</p> <p>Fair Condition: Equipment meets manufacturer's specifications with age related general wear, all sections and fixings checked secure and sound. Equipment passed safe for its intended use at time of inspection.</p> <p>Some rusting present as highlighted - Monitor</p>
<p>6</p>

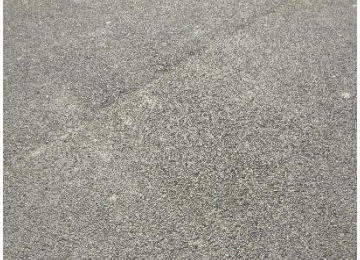
<p>Safe Surface – Hardcourt</p> <p>Generally in Fair Condition throughout with age related wear , no significant areas of damage , tripping hazards or breakup identified. Minor areas of shrinkage around perimeter areas. Safer Surface complying with BS EN 1177</p>
