### Edington Parish Council Playground

## 2026 Equipment Inspection Report

### DTGS LTD

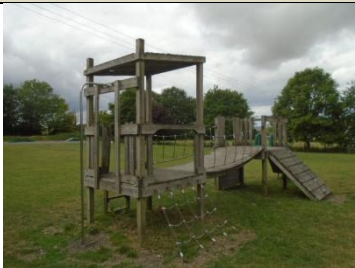
| <b>Site: School Playground / Field.</b><br><b>Disability Access:</b> Generally accessible – An area accessible to most but not all people, even when help is available. | | <b>Equipment Type &amp; Manufacturer:</b><br><br><b>Equipment:</b> MPU<br><br><b>Manufacturer:</b> Play Force | <b>Safety Surface Type:</b><br>Rubber Tiles<br><b>Compliance Standards:</b><br>BS EN 1176<br>BS EN 1177 |
|---|---|---|---|
| 1<br><br> | | <b>MPU Frame (1)</b><br><br>Fair Condition - The frame structure generally complies with BS EN 1176 standards. Subject to any recommended repairs / maintenance recommended being carried out. The equipment is considered sound & safe to use at time of inspection and although ageing still sound and safe to use at the time of inspection. All timbers would benefit from the application of additional wood preservative treatment during next maintenance cycle to prevent accelerated timber and frame deterioration in high use equipment. | |

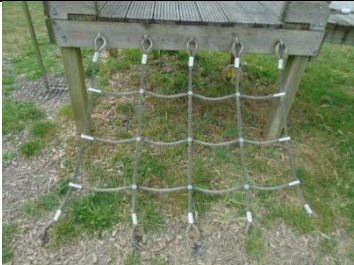
| 2<br><br> | | <b>Mini Net Climb</b><br><br>Fair Condition – Net is aged but in a safe and sound condition at time of inspection with secure fixings and frame attachments. Wire cored rope all sound with ferules tight & Secure, no flayed or splintering wire evident. |

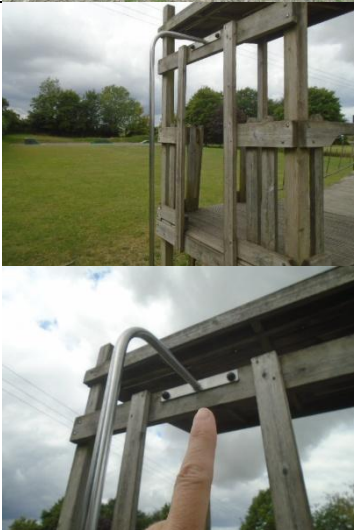
| 3<br><br> | | <b>Fireman's Pole</b><br><br>Fair > Poor Condition - Grip requirements met (16mm – 45mm) of BS EN 1176 Part 1. No damage to metal surfaces. with pole firmly fixed and secure into the play surface. Fixings slightly loose at top of pole as highlighted – Maintenance required to tighten loose fixings to reduce injury risks from failure under load. |

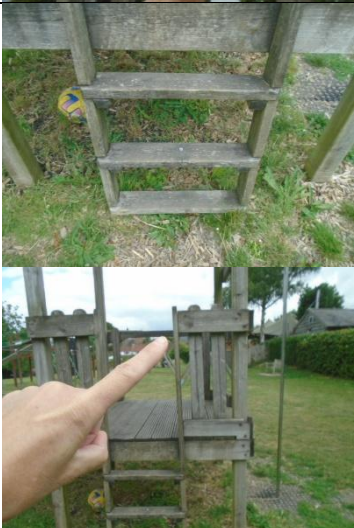
| 4<br><br> | | <b>Timber Steps / Ladder</b><br><br>Fair Condition -Timber worn with age related wear evident but sound with no roughness to frame or rungs, splintering or cracking and safe to use at time of inspection. Some minor movement in left side timber upright support as indicated - Monitor |

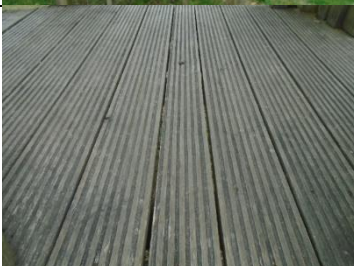
| 5<br><br> | | <b>Platform (2)</b><br><br>Generally in Fair Condition throughout with all timber platform, frame sections & fixings checked secure with no significant damage evident at time of inspection. |

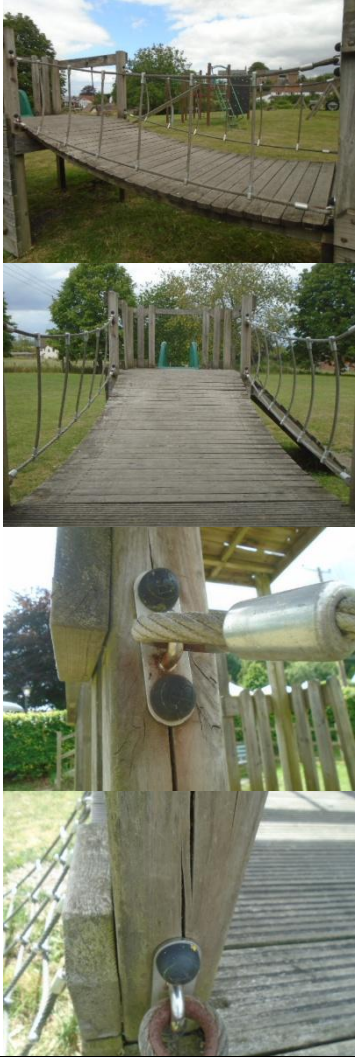
| <p>6</p> | | <p><b>Bridge</b></p> <p>Fair Condition - Bridge frame and supporting Timbers all sound with age related wear. No significant Timber damage evident. Some splits adjacent to fixing points as highlighted – Monitor. Fixings checked tight and secure with no significant wear or wire splintering evident in ropes.</p> <p>Evidence of being highly slippery in damp conditions. Recommend fitting with non-slip safety surface during next maintenance cycle.</p> <p><i>Repairs / Recommended Maintenance :- To supply &amp; Fit new heavy duty High Visibility Resin Anti Slip strips with silicone fixing and frame screws to each bridge tread board @ £325.00 ( Includes 5 year guarantee )</i></p> |

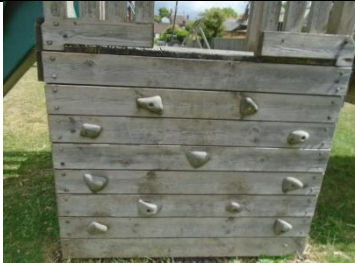
| <p>7</p> | | <p><b>Climbing Panel</b></p> <p>Fair Condition - with Hand and Foot holds checked and tightened where necessary. Timber surfaces checked smooth with no splinter risks at time of inspection. High use areas such as Traversing Walls require regular checking for the security of all fixings and potential splintering risks</p> |

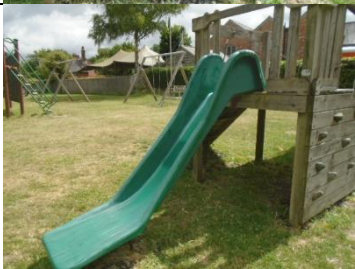
| <p>8</p> | | <p><b>Slide</b></p> <p>Fair Condition – Structure and frame securely attached to entrance platform and ground surface with no free movement, exposed fixings or fatigue present in Slide securing points &amp; edges. Slide Chute surfaces are smooth with no cracking, fractures or splintering evident at time of inspection.</p> |

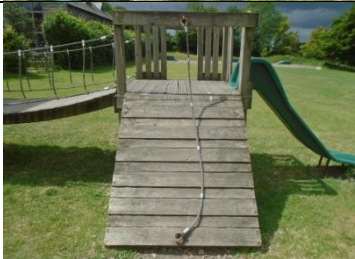
| <p>9</p> | | <p><b>Ramp &amp; Pull Rope</b></p> <p>Fair Condition - With timber ramp sections and fixings secure. Wire cored rope all sound with ferules tight &amp; Secure, no frayed or splintering wire evident. High use areas such as climbing ramps require regular checking for the security of all fixings.</p> |

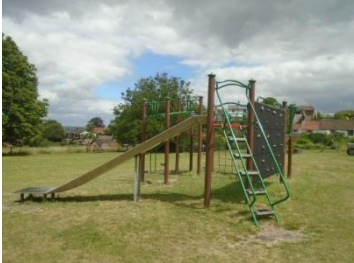
| 10<br><br> | | <b>MPU (2)</b><br><br>Fair Condition - The frame structure generally complies with BS EN 1176 standards. Subject to any recommended repairs / maintenance recommended being carried out. The equipment is considered sound & safe to use at time of inspection and although ageing still sound and safe to use at the time of inspection. |

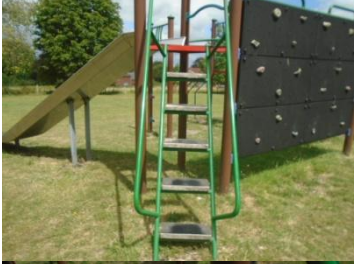
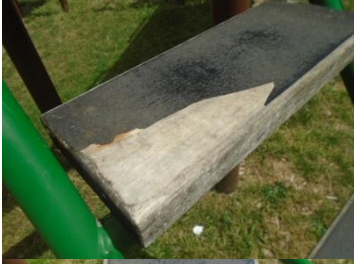
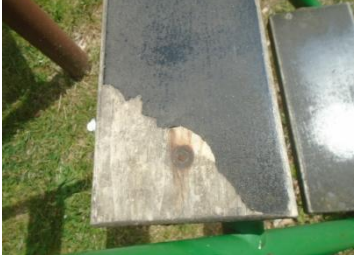
| 11<br><br> | <br><br> | <b>Ladder</b><br><br>Fair Condition with no movement at base level. Ladder rungs secure with all fixings present and tight and secure<br><br>2 steps found with detaching anti slip surfacing peeling away – Maintenance recommended to fit rigid anti slip strips<br><br><i>Repairs / Recommended Maintenance :- To supply &amp; Fit new 60cm heavy duty High Visibility Resin Anti Slip strips with silicone fixing and frame screws to each step @ £150 ( Includes 5 year guarantee )</i> |

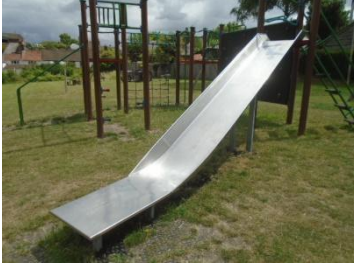
| 12<br><br> | | <b>Steel Slide</b><br><br>Frame in Fair Condition with sound welds, undamaged surfaces. Rail structure securely attached to entrance platform and ground surface with no free movement, exposed fixings or fatigue present in frame securing points & edges. |

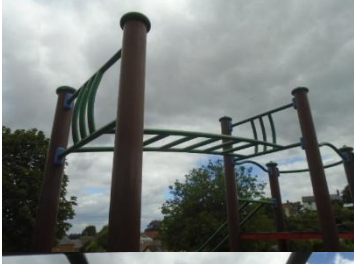
| 13<br><br> | <br> | <b>Monkey Bars</b><br><br>Fair Condition. All hand bars and frame fixings checked tight and secure with no looseness or twisting in the frame at time of inspection. |

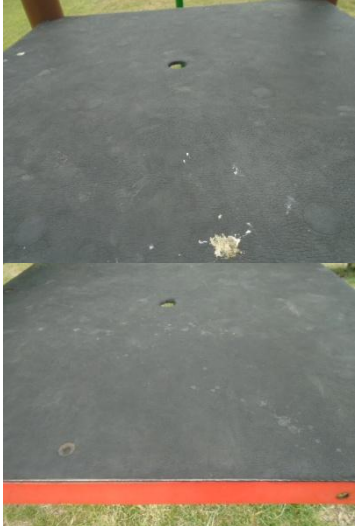
| 14<br><br> | | <b>Platforms</b><br><br>Generally in Fair Condition throughout with all platform, frame sections & fixings checked secure with no significant damage evident at time of inspection. |

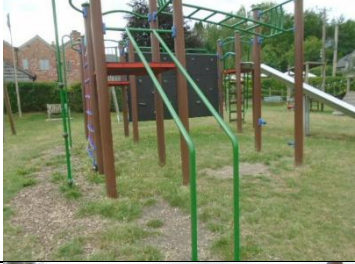
| 15<br><br> | | <b>Parallel Poles</b><br><br>Fair Condition - No damage to metal surfaces. with poles firmly fixed and secure into the play surface |

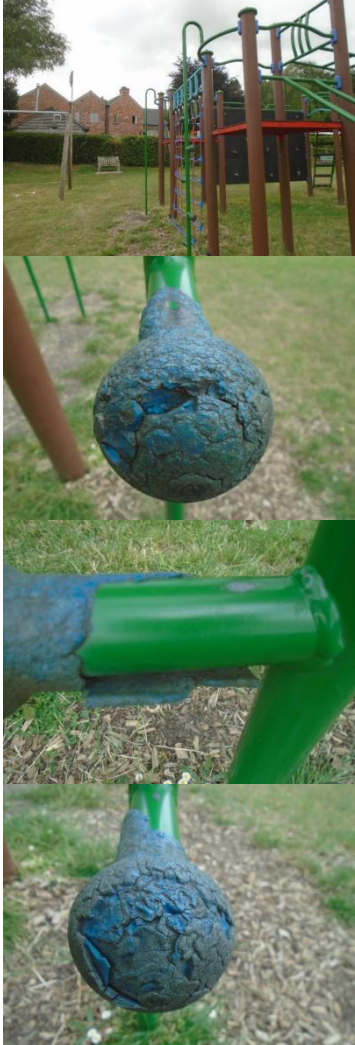
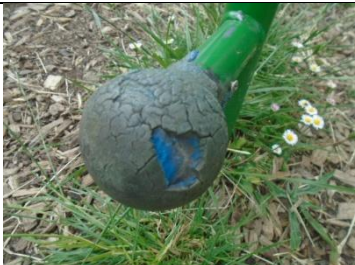
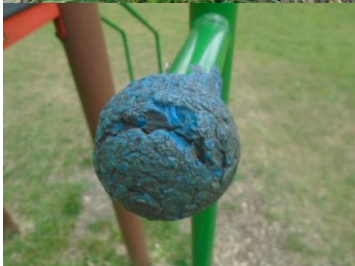
| 16<br><br> | | <b>Peg Ladder</b><br><br>Fair > Poor Condition – Pegs in Fair Condition with sound welds, undamaged paint surfaces.<br><br>Rubber grips in Poor Condition due to perishing as highlighted. Recommend replacement to reduce risk of injuries<br><br><i>This repair / maintenance issue is considered to be a more cost-effective proposition if monitored and carried out by the original equipment suppliers or installers and for this reason DTGS has not provided a repair quotation</i> |

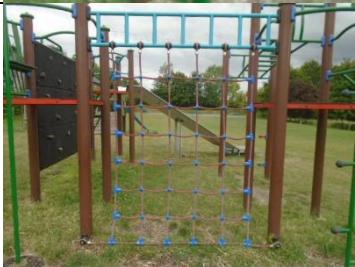
| 17<br><br> | | <b>Scramble Net</b><br><br>Fair Condition – Net is aged but in a safe and sound condition at time of inspection with secure fixings and frame attachments. |

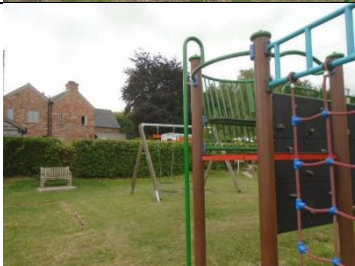
| 18<br><br> | | <b>Fireman's Pole</b><br><br>Fair Condition grip requirements met (16mm – 45mm) of BS EN 1176 Part 1, with all fixings tight and secure. No damage to metal surfaces. with pole firmly fixed and secure into the play surface |

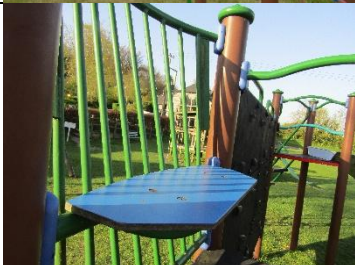
| 19<br><br> | | <b>Raised Timber Seat</b><br><br>Generally in Fair Condition with all timber seating, ground supports, frame sections , table top and fixings checked secure at time of inspection. |

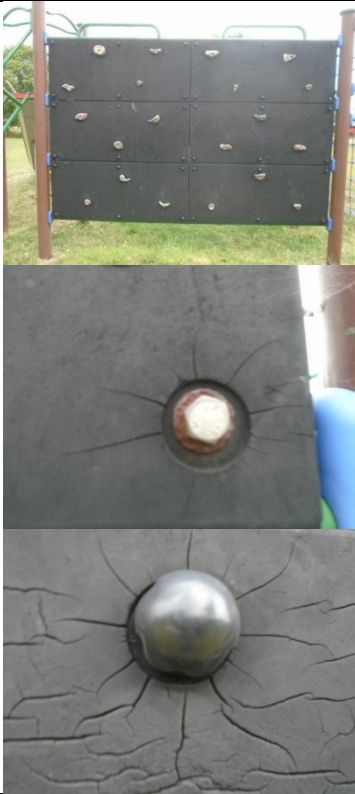
| <p>20</p> | | <p><b>Traversing Panel</b></p> <p>Fair Condition with Hand and Foot holds checked and tightened where necessary / or possible . High use areas such as Traversing Walls require regular checking for the security of all fixings.</p> <p>1x missing fixing cap presenting exposed fixings and sharp edges – as these are in areas easily accessible to users recommend re fitting caps to reduce risk of potential abrasion injuries</p> <p><i>This repair / maintenance issue is considered to be a more cost-effective proposition if monitored and carried out by the site maintenance team and for this reason DTGS has not provided a repair quotation</i></p> <p>Rubberised backboard is beginning to crack as highlighted – Monitor</p> |

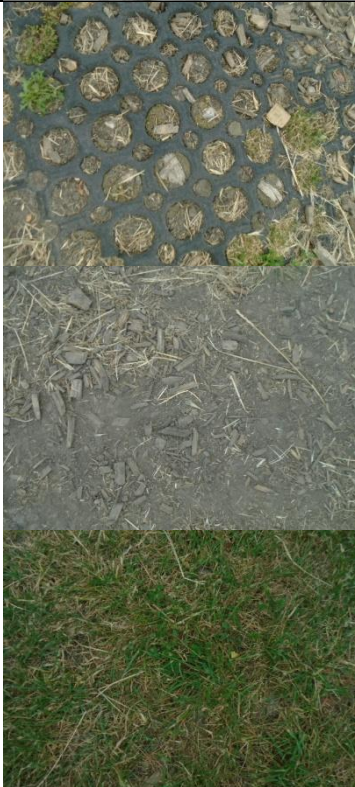
| <p>21</p> | | <p><b>Safe Surface</b></p> <p><b>Rubber Tiles:</b><br/>Fair Condition with all matting secured to play surface with apposite ground fixings, seated edges into the surface with no areas of damage or trip hazards identified at time of inspection</p> <p><b>Loose Fill:</b><br/>The level of loose filling has fallen significantly below the minimum of 200mm recommended by BS EN 1176 Part 1. Recommend topping up loose fill surfacing to recommended minimum levels.</p> <p><b>Seeded Grass</b><br/>Fair Condition - The surface is generally even with no significant areas of damage , wear or tripping hazards identified. Some higher use areas have eroded resulting in compacted open areas of soil which is slippery in damp conditions. Recommend reinstatement of surface during next maintenance cycle</p> |

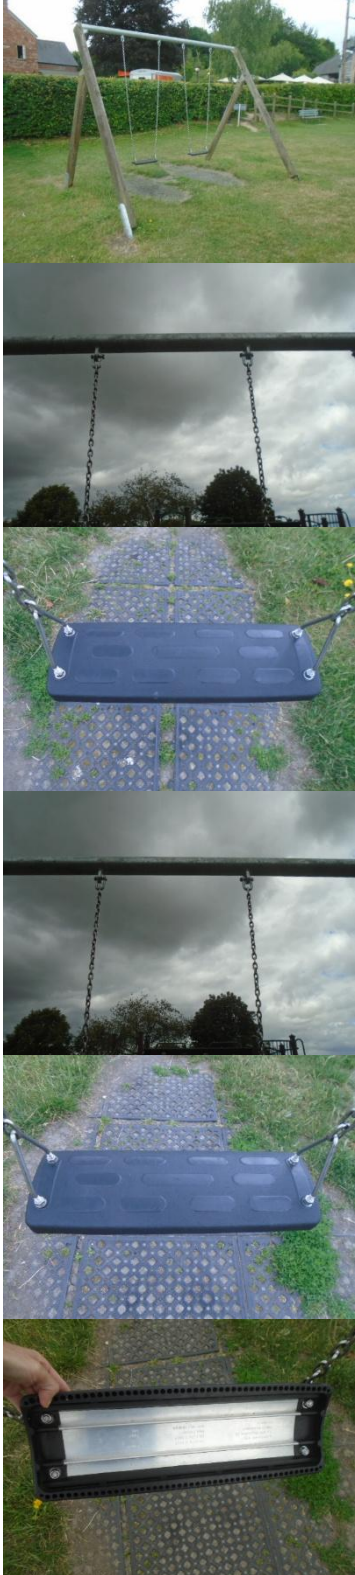
| <div>22</div> <div></div> <div></div> | | <p><b>Swing (1)</b></p> <p><b>Timber Frame:</b></p> <p>Fair Condition - Timber frame is generally weathered and worn with age related wear.</p> <p><b>Swing Mechanism:</b></p> <p>Both swings move smoothly and noiselessly<br/>Chains and safety shackles checked and secure with minimal wear evident.<br/>Pivot pins, bushes secure and free from excessive movement. All chain connections checked intact and secure with minimal wear evident.</p> <p><b>Standard Seats ( for ages 3-12 yrs )</b></p> <p>Good Condition with no damage or cracking to EPDM rubber seat or Aluminium insert reinforcement. Seats set at compliant heights. Chain connections, fixings checked tight &amp; Secure.</p> |

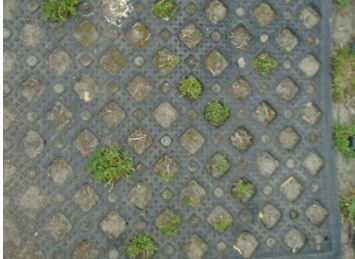
| <div>23</div> <div></div> <div></div> | | <p><b>Safe Surface – Rubber Matting</b></p> <p>Generally in Fair Condition with all matting secured to play surface with apposite ground fixings, seated edges into the surface with no areas of damage or trip hazards identified at time of inspection</p> |

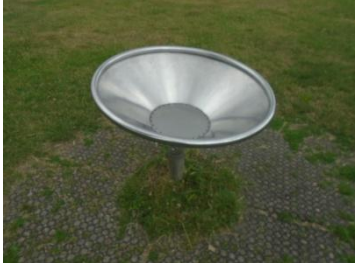
| 24<br><br> | | <p><b>Carousel</b></p> <p>Fair Condition – with all supports fixed securely at ground level with no movement. Inclined platform is smooth, undamaged and rotates freely in both directions with bearing covers fixed and secure.</p> |

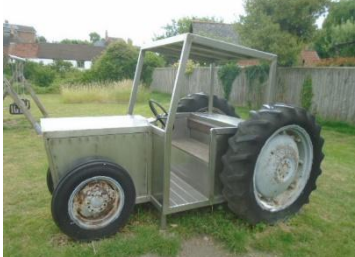
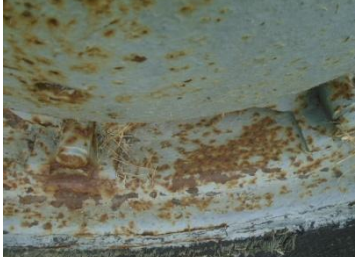
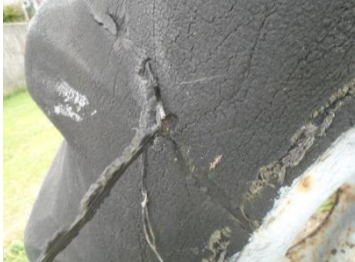
| 25<br><br> | <br><br> | <p><b>Tractor</b></p> <p>Generally in Fair &gt; Poor Condition for age and use. This equipment is not of commercial playground standard and should be monitored carefully during use. 1 Tyre wall damaged with cracked rubber and exposed wire banding evident – not wire splinters at time of inspection but this requires remedial repairs to reduce further deterioration and injury risks</p> <p>Monitor rust on wheels as highlighted .</p> |

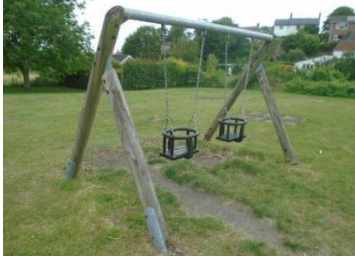
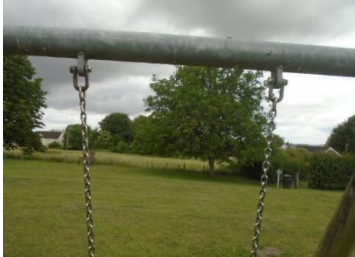
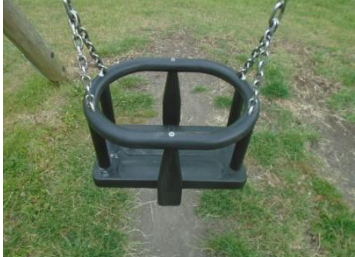
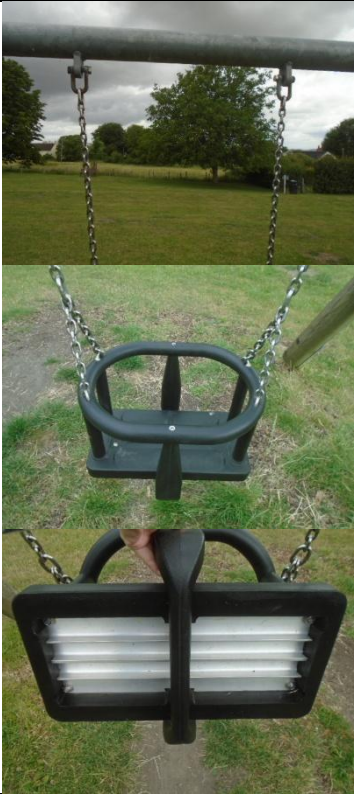
| 26<br><br> | <br><br> | <p><b>Swing (2)</b></p> <p><b>Timber Frame:</b></p> <p>Fair Condition - Timber frame is generally weathered and worn with age related wear.</p> <p><b>Swing Mechanism:</b></p> <p>Both swings move smoothly and noiselessly</p> <p>Chains and safety shackles checked and secure with minimal wear evident. Pivot pins, bushes secure and free from excessive movement. All chain connections checked intact and secure with minimal wear evident.</p> <p><b>Standard Seats ( for ages 3-12 yrs )</b></p> <p>Good Condition with no damage or cracking to EPDM rubber seat or Aluminium insert reinforcement. Seats set at compliant heights. Chain connections, fixings checked tight &amp; Secure.</p> |

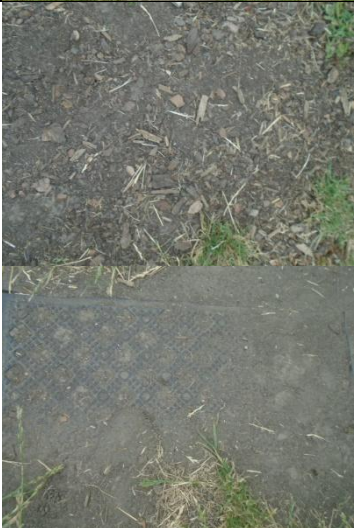
| 27<br><br> | | <p><b>Safe Surface</b></p> <p><b>Loose Fill:</b><br/>The level of loose filling has fallen significantly below the minimum of 200mm recommended by BS EN 1176 Part 1. Recommend topping up loose fill surfacing to recommended minimum levels.</p> <p><b>Rubber Tiles:</b><br/>Fair &gt; Poor Condition with all matting secured to play surface with apposite ground fixings, seated edges into the surface with no areas of damage or trip hazards identified at time of inspection<br/>Protective rubber matting is compacted into the muddy ground surface and no longer impact absorbing.</p> |

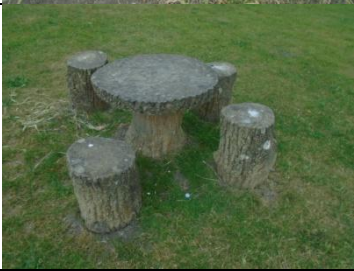
| 28<br><br> | | <p><b>Timber Seating and Table</b></p> <p>Fair Condition with all timber seating, ground supports, frame sections and fixings checked secure at time of inspection.</p> |

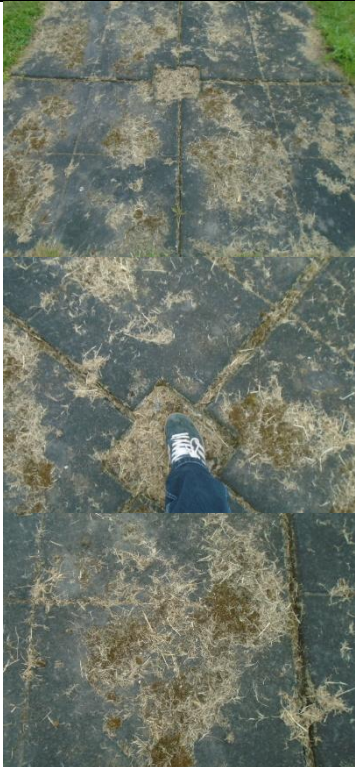
| <p>29</p> <p></p> <p></p> | | <p><b>Safe Surface (where previous equipment was installed)</b></p> <p><b>Rubber Tiles</b></p> <p>Fair &gt; Poor Condition with all matting secured to play surface with apposite ground fixings, seated edges into the surface. There are holes where previous equipment has been removed presenting trip hazards as highlighted.</p> <p>Excessive weed &amp; Moss growth in surrounding areas. Recommend this is treated to reinstate safe surface and avoid further damage to surface edging . Weed growth in safety surfaces also leads to tripping points , particularly in damp conditions. Recommend removal of weeds and treatment of surface with playground safe weed control.</p> <p>Maintenance recommended to repair / reinstate safety surface during next maintenance cycle</p> <p><i>This repair / maintenance issue is considered to be a more cost-effective proposition if monitored and carried out by the site maintenance team and for this reason DTGS has not provided a repair quotation</i></p> |

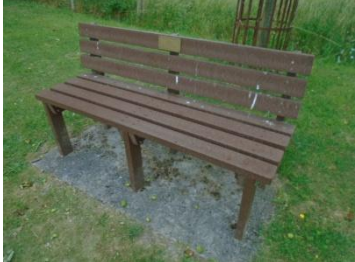
| <p>30</p> <p></p> <p></p> | | <p><b>Composite Bench</b></p> <p>Good &gt; Fair Condition with all composite Plastic seating, table top, frame sections and fixings checked secure at time of inspection. Support sections firmly seated / embedded / attached to playground surface.</p> |

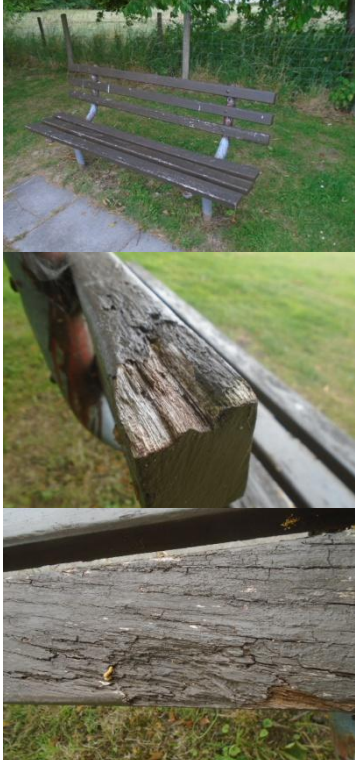
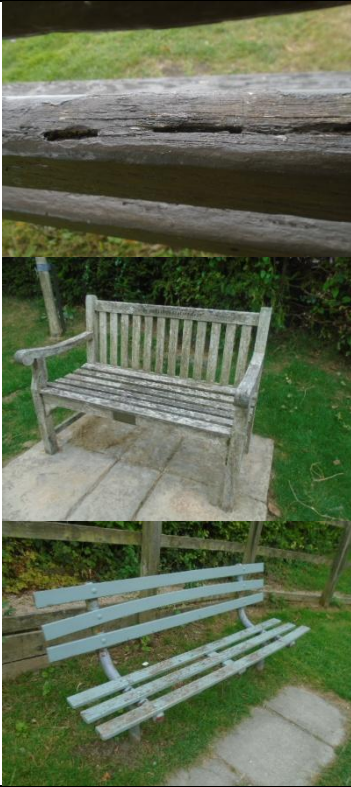
| <p>31</p> <p></p> <p></p> | | <p><b>Timber Bench (3)</b></p> <p>2 Fair Condition with all timber seating, ground supports, frame sections and fixings checked secure at time of inspection.</p> <p>1 Fair &gt; Poor Condition with all timber seating, frame sections and fixings checked secure at time of inspection. Some timber decay / damage to seating timbers presenting splinter injury risk . Maintenance required the repair / replace affected timber and fixings to reduce injury risk.</p> <p><i>This repair / maintenance issue is considered to be a more cost-effective proposition if monitored and carried out by the site maintenance team and for this reason DTGS has not provided a repair quotation</i></p> |

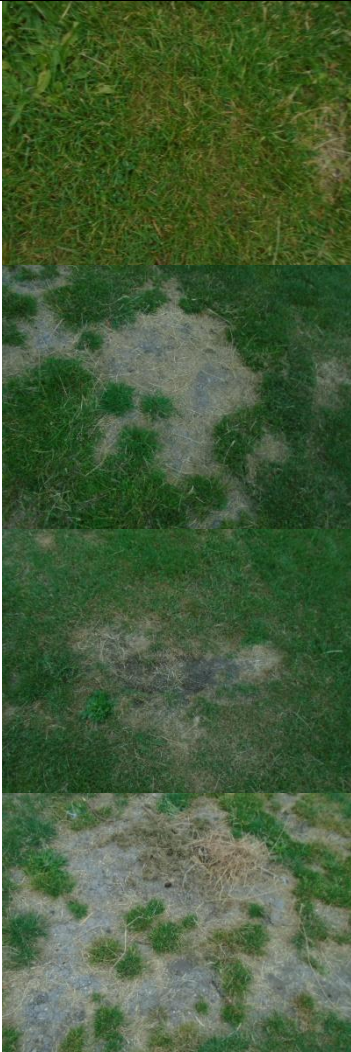
| <p>32</p> | | <p><b>Safe Surface – Seeded Grass</b></p> <p>Fair &gt; Poor Condition – The grass surface has eroded significantly in some areas of high use and is very muddy in wet / damp conditions easily leading to trips, slips and falls. The current surface fails the compliance requirements of BS EN 1177. Recommend that the protective surface is reinstated.</p> |

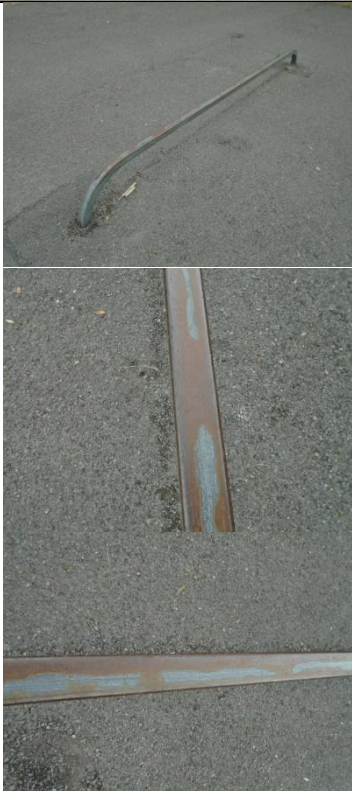
#### Skate Rail 1

Fair Condition: Equipment meets manufacturer's specifications with age related general wear, all sections and fixings checked secure and sound. Equipment passed safe for its intended use at time of inspection.

Some rusting present as highlighted –Monitor

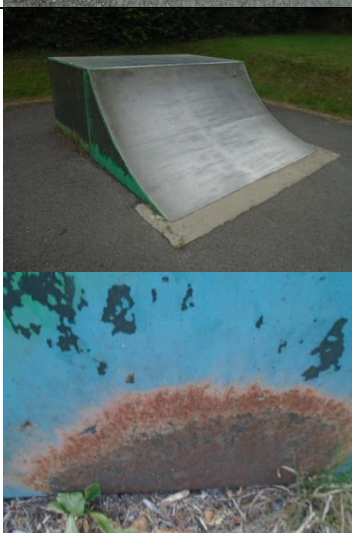
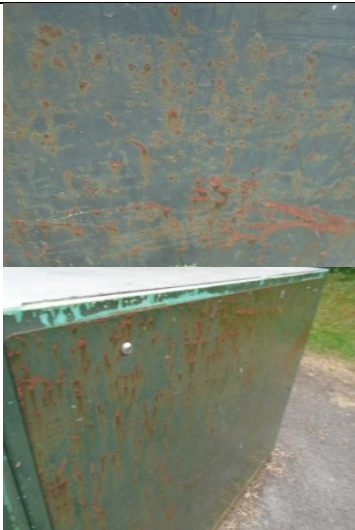
#### Skate Ramp 1

Fair Condition: Equipment meets manufacturer's specifications with age related general wear, all sections and fixings checked secure and sound. Equipment passed safe for its intended use at time of inspection.

Some rusting present on side panels as highlighted – Maintenance required to reinstate painted surface, remove rust to reduce risks of infection / abrasion for users and to prevent further deterioration of equipment

*This repair / maintenance issue is considered to be a more cost-effective proposition if monitored and carried out by the site maintenance team and for this reason DTGS has not provided a repair quotation*

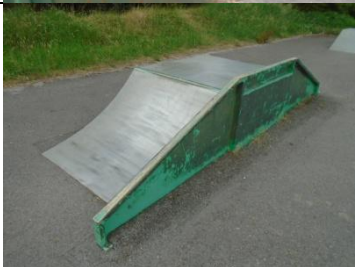
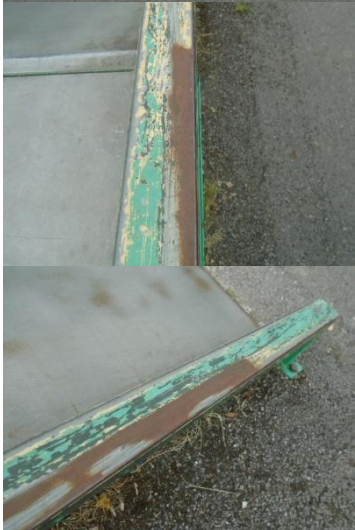
| 3<br><br> | <br> | <b>Skate Ramp 2</b><br><br>Fair Condition: Equipment meets manufacturer's specifications with age related general wear, all sections and fixings checked secure and sound. Equipment passed safe for its intended use at time of inspection.<br><br>Some rusting present as highlighted on side rail sections—monitor |

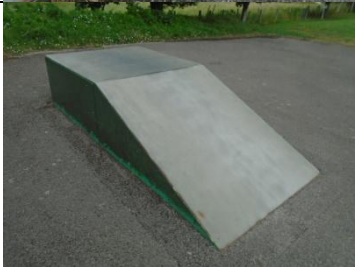
| 4<br><br> | | <b>Skate Ramp 3</b><br><br>Fair Condition: Equipment meets manufacturer's specifications with age related general wear, all sections and fixings checked secure and sound. Equipment passed safe for its intended use at time of inspection. |

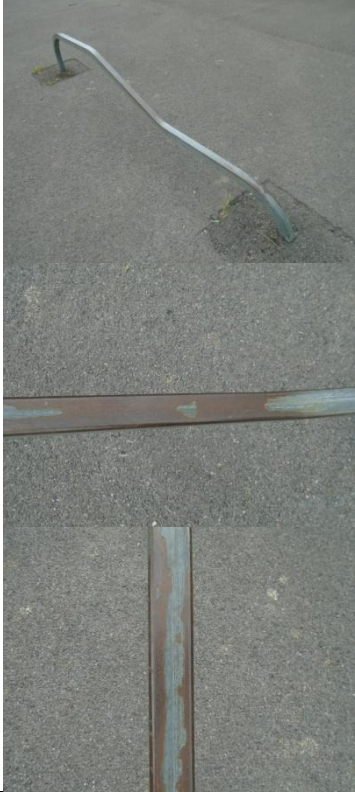
| <p>5</p> | | <p><b>Skate Rail 2</b></p> <p>Fair Condition: Equipment meets manufacturer's specifications with age related general wear, all sections and fixings checked secure and sound. Equipment passed safe for its intended use at time of inspection.</p> <p>Some rusting present as highlighted - Monitor</p> |

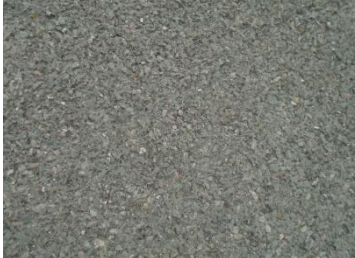
| <p>6</p> | | <p><b>Safe Surface – Hardcourt</b></p> <p>Generally in Fair Condition throughout with age related wear , no significant areas of damage , tripping hazards or breakup identified. Minor areas of shrinkage around perimeter areas. Safer Surface complying with BS EN 1177</p> |
