Edington Parish Council Playground

Behind , 47 Westbury Road, Edington, Westbury, BA13 4PG

2026 Equipment Inspection Report

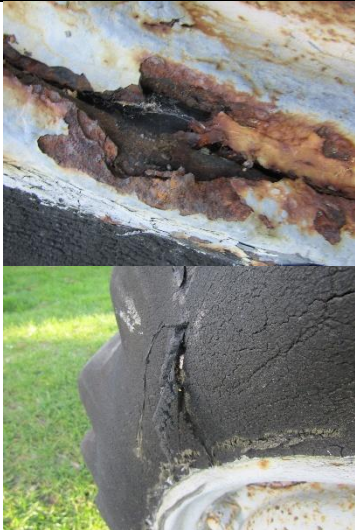
26

<p>23</p> <p></p> <p></p>		<p>Safe Surface – Rubber Matting</p> <p>Generally in Fair Condition with all matting secured to play surface with apposite ground fixings, seated edges into the surface with no areas of damage or trip hazards identified at time of inspection</p>
<p>24</p> <p></p> <p></p>		<p>Carousel</p> <p>Fair Condition – with all supports fixed securely at ground level with no movement. Inclined platform is smooth, undamaged and rotates freely in both directions with bearing covers fixed and secure.</p>
<p>25</p> <p></p> <p></p>		<p>Tractor</p> <p>Generally in Fair > Poor Condition for age and use. This equipment is not of commercial playground standard and should be monitored carefully during use. Large metal wheel frame found with significant rusting as shown with sharp jagged edges with finger sized access holes presenting significant finger injury / entrapment risks – Priority maintenance required to repair or replace this damaged section.</p> <p>1 Tyre wall damaged with cracked rubber and exposed wire banding evident – not wire splinters at time of inspection but this requires remedial repairs to reduce further deterioration and injury risks</p>
